How Contaminated are Pipetman?

*By Kayla Taggard
June 2020*

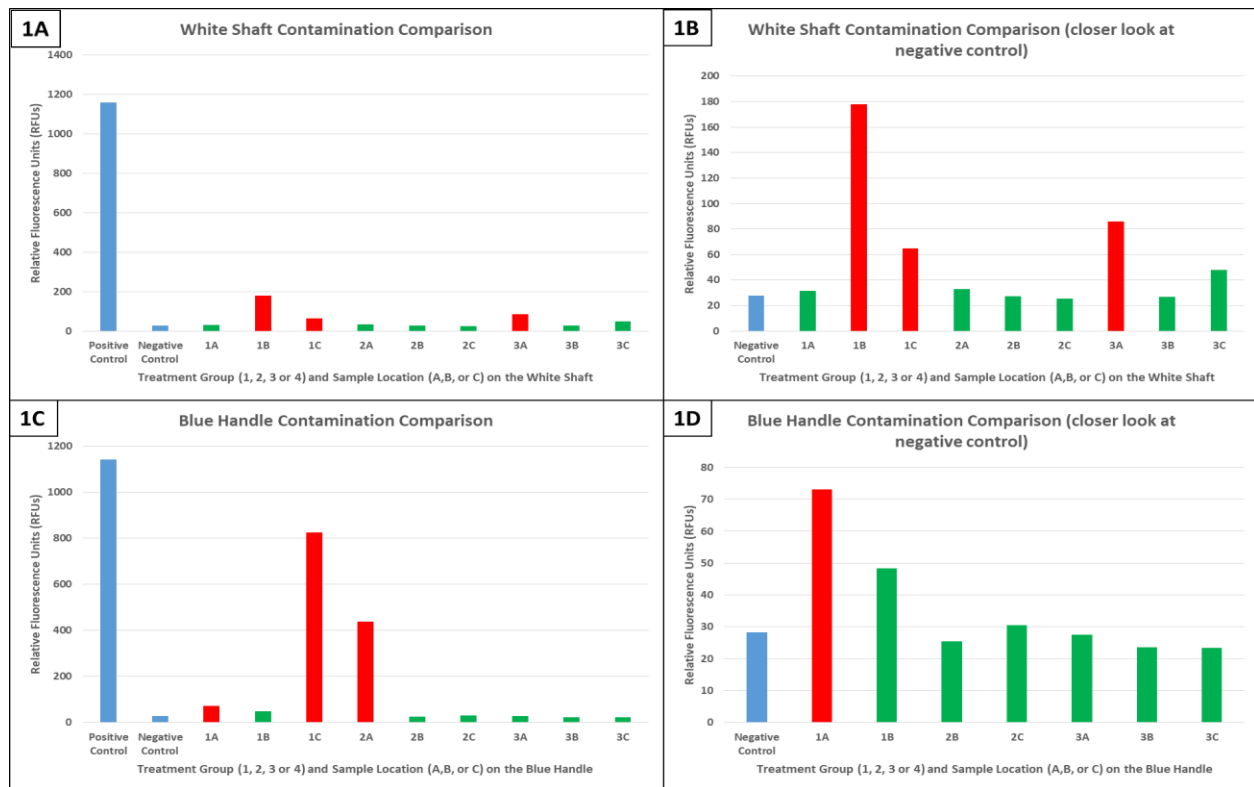
Figure 1: Contamination on Blue Handle and White Shaft in the Three Treatment Groups

This figure compares the level of contamination (in RFUs) present on the blue handles and white shafts of pipetman in three different treatment groups. Samples were re-suspended in nuclease free water and read in a Gemini XPS fluorimeter using IDT reagents. Data represented here is the last reading from the Gemini for each sample (or an average of the last readings for the three handle and shaft positive controls). Red columns represent contamination (significantly above negative control) and green columns represent no contamination (samples that are statistically within the negative control). The statistical cutoff for contamination was 60 RFUs.

Treatment Groups were as follows:

1. Benchtop: A pipetman that has been sitting on a common laboratory benchtop and used without being regularly cleaned.
2. RNase-free Hood: Pipetman that was cleaned into the RNase-free hood (using homemade RNase ∞ Plastics spray) and has been used regularly but not re-cleaned since.
3. RNase Solution: Pipetman tested immediately after being manually cleaned with an RNase decontamination solution.

The first group examined a pipette which was left on an open benchtop and used for every-day laboratory activities without being cleaned. Sampling six locations on this benchtop pipette (three on the blue handle and three on the white shaft) we found that four showed contamination, with RFUs of these samples ranging from 65 to 825 (see Figure 1). Thus quantifying what has been institutionally known in almost any microbiology lab: your pipetman are not clean. Another notable result was the identity of the most contaminated sample, the blue handle sample C (see Figure 1C). Taken from the ejector button of the blue handle, this sample was highly contaminated in comparison to the rest of the group. Suggesting that not only are benchtop pipetman contaminated, but also where that contamination is likely to be concentrated. Armed with the knowledge of how contaminated pipetman can become we next set out to determine the effectiveness of two common treatment methods, chemical cleaning and protection in an RNase-free hood.

To test the effectiveness of an RNase decontamination solution we spotted a clean pipette with 1uL samples of 0.02u/mL RNaseA, allowed the samples to dry, then cleaned with the spray. Immediate re-suspension after cleaning revealed that while the solution did indeed eliminate RNase contamination as expected (see Figure 1) it was also subject to human error. The one sample showing contamination, sample 3A of the white shaft (see Figure 1B), implicates errors in wiping technique when using the spray. Showing that chemical decontamination is effective but fallible. Our last treatment group adds to this finding and hints that even without human error it is still possible for equipment to become contaminated.

For the last treatment group we tested a pipette that had been previously well-cleaned into the RNase-free hood and remained there for multiple days. Here we see sample 2A of the handle (Figure 1C) showing an RFU of 438. This significant level of contamination could potentially be a result of the aforementioned human error in chemically cleaning pipettes. Or, more ominously, it might also indicate fallibility of
